EYE SPY HOME INSPECTIONS, LLC

Inspection Report

Date: 8/8/2022	Time: 08:00 AM	Report ID: Sample_Report_1
Property: 1504 Georgia St NE Portland Or 97000	Customer: Clients Name	Real Estate Professional:

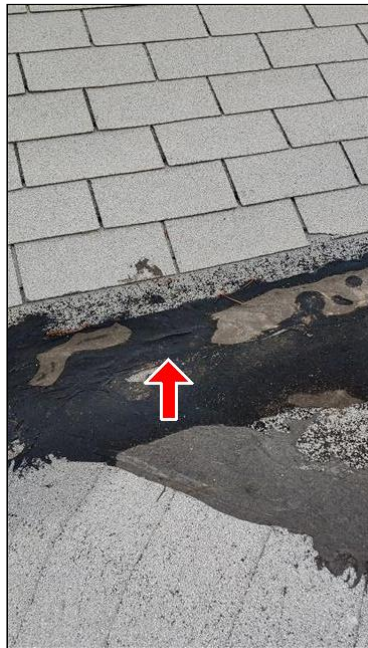
2.0 Item 1(Picture)

At the time of the inspection the valley between the two ridge lines functioned as designed. However, this area will require periodic maintenance to prevent possible water infiltration into the attic or home. Any cracks in the roofing mastic (black sealant) will need to be re-sealed as soon as possible.

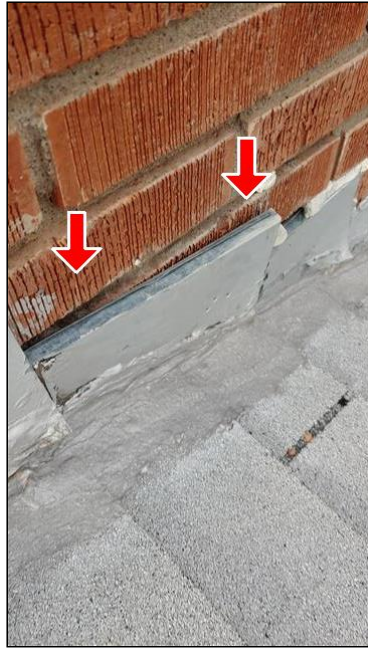
2.1 Item 1(Picture)

The step flashing on the chimney is improperly installed and the flashing sealant is beginning to deteriorate. Suggest consultation with a certified roofing company as to corrections.

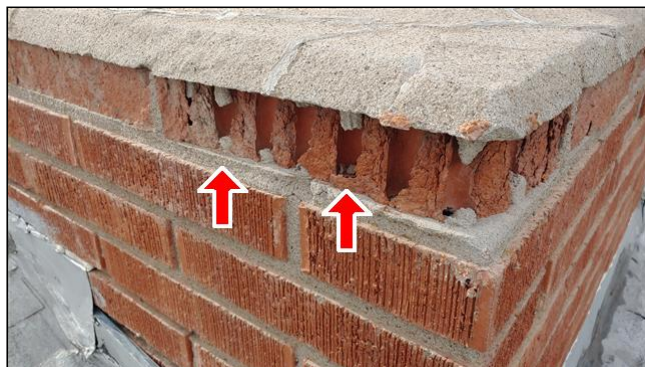
2.2 Item 1(Picture)

(1) The top row of brick around the chimney is beginning to spall and crack. Over time, this could lead to water damage to the chimney.

Suggest sealing the bricks or having the a new top layer of brick installed.

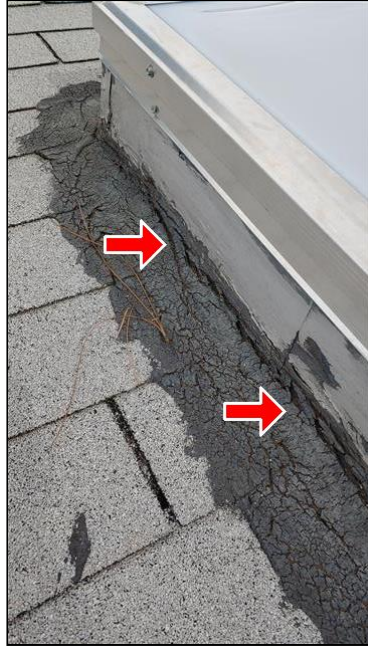
2.2 Item 4(Picture)

(2) The roofing mastic around the skylight is beginning to deteriorate and crack. This could lead to leaking into the home. Suggest re-sealing the roofing mastic around the skylight.

This skylight could be the source of the water damage in the family room (skylight near the fire place).

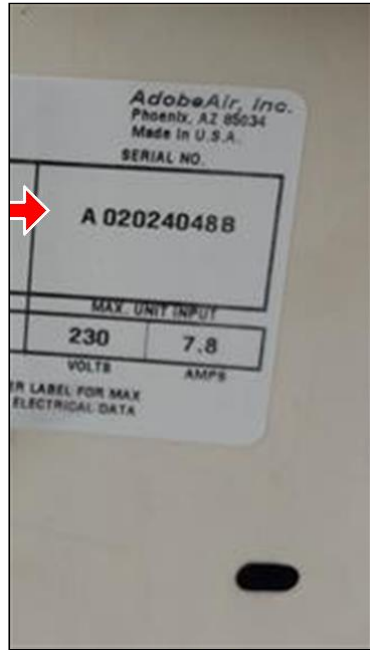
3.0 Item 1(Picture)

The age of the AC unit was not able to be determined due to the manufacture (Adobear Inc) went out of business 15 years ago. The model number indicates the unit was built in the mid 1980's.

The unit appeared to be in serviceable condition with no or little rust.

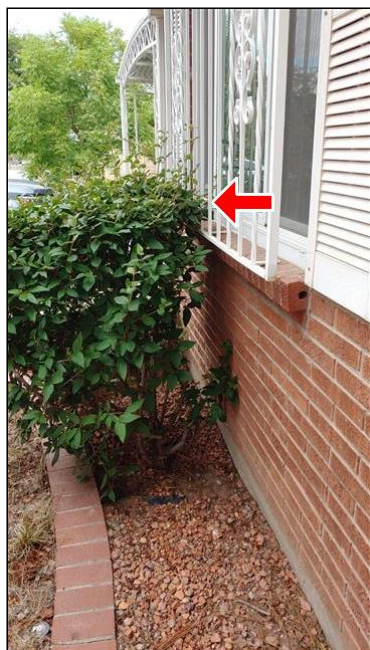
4.4 Item 1(Picture)

(1) Vegetation should be trimmed back and kept from touching the siding or the house. Vegetation can hold moisture and increase the possibility of moisture damage to walls, siding and foundations.

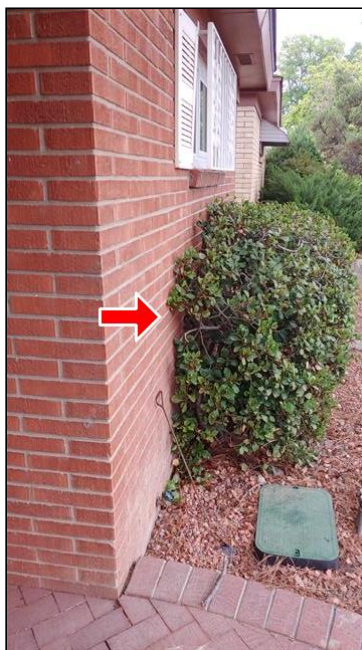
4.4 Item 2(Picture)

(2) Due to the home having a crawl space, the gutter down spouts should terminate at least 3 feet from the exterior walls of the home to prevent water intrusion into the crawl space.

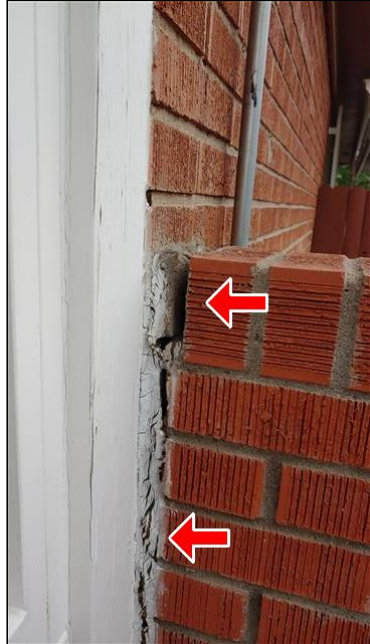
4.4 Item 4(Picture)

(3) The wall supporting the gate on the north side of the house has begun to detach from the house. This movement has resulted in a large gap that could allow water to get between the wall and the house wall.

Suggest sealing the crack.

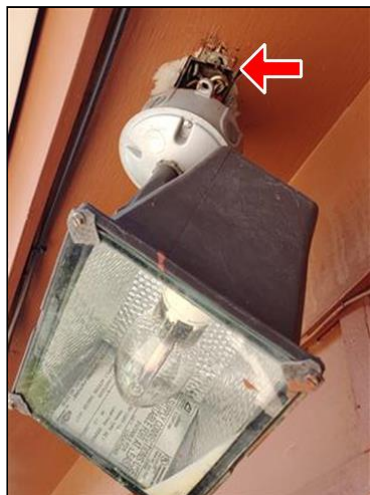
4.7 Item 1(Picture)

(1) The driveway light is coming loose from the soffit.

Suggest reattaching the light.

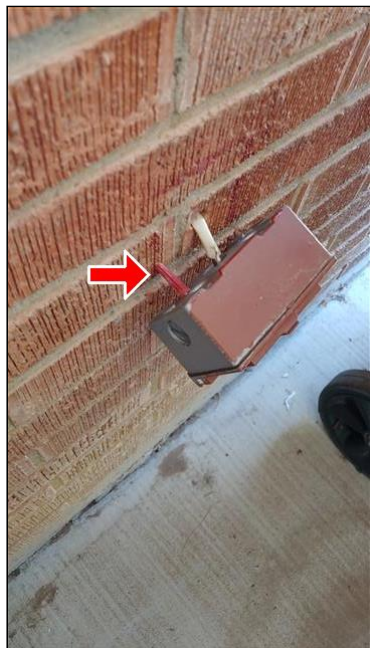
4.7 Item 2(Picture)

(2) The wall outlet on the North side of the garage is loose.

Suggest re-installing the outlet.

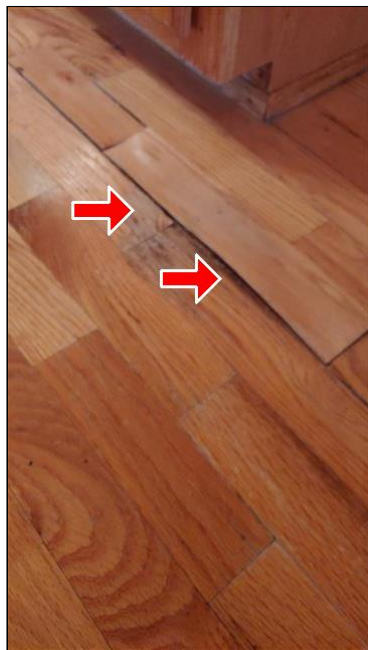
5.2 Item 1(Picture)

The flooring shows signs of previous water damage near the refrigerator.

Suggest replacing damaged flooring.

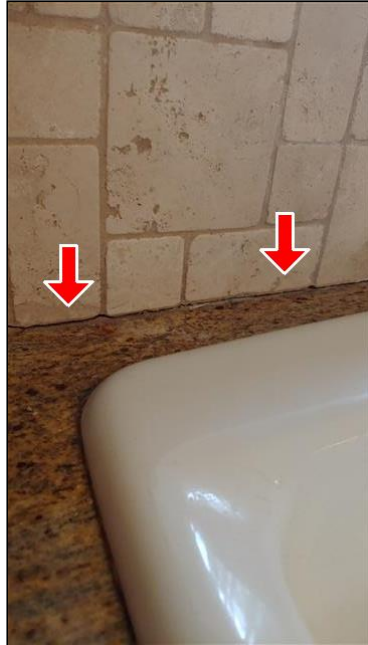
5.5 Item 1(Picture)

The kitchen counter grout at the back-splash is beginning to fail and crack.

Suggest re-grouting or caulking the back-splash.

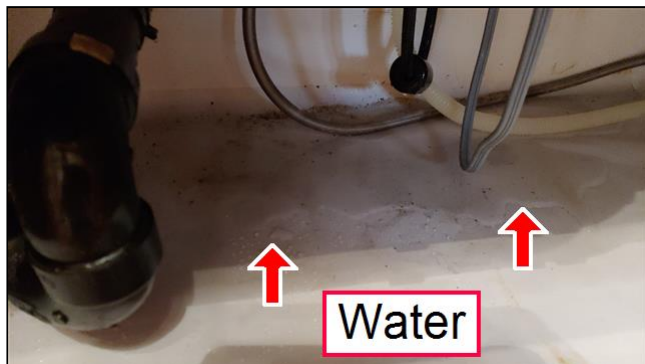
5.7 Item 1(Picture)

The kitchen faucet leaks.

Suggest replacing faucet.

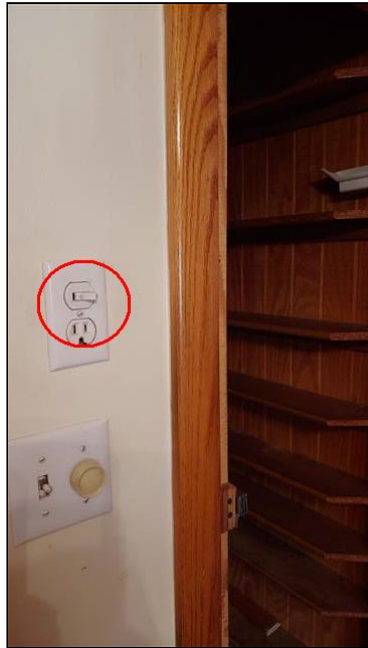
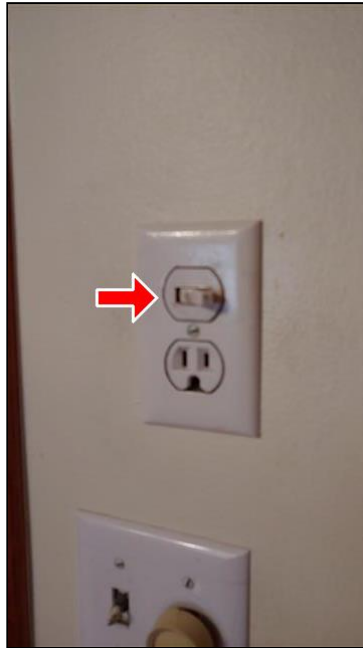
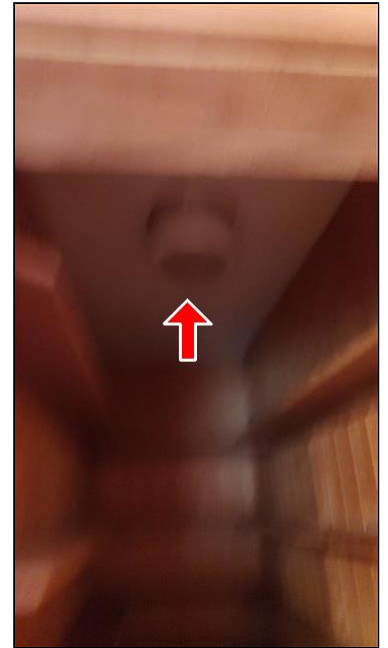
5.8 Item 1(Picture)

The overhead light switch for the pantry light does not function as designed.

Strongly suggest replacing switch.

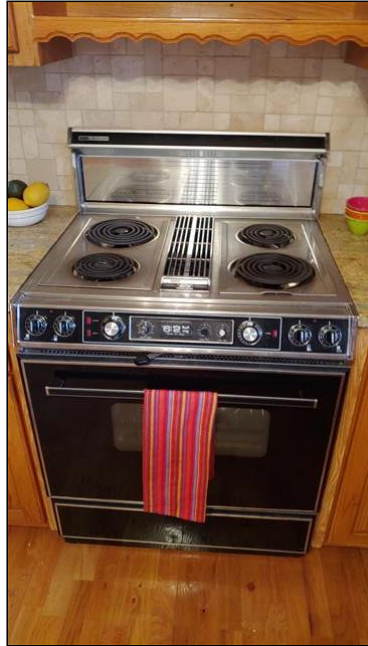
5.10 Item 1(Picture)

(1) The stove does not have an anti-tip device. This is a safety issue as the oven could tip over if the door is opened and something heavy is placed on the door (like a child).

Suggest installing an anti-tip device.

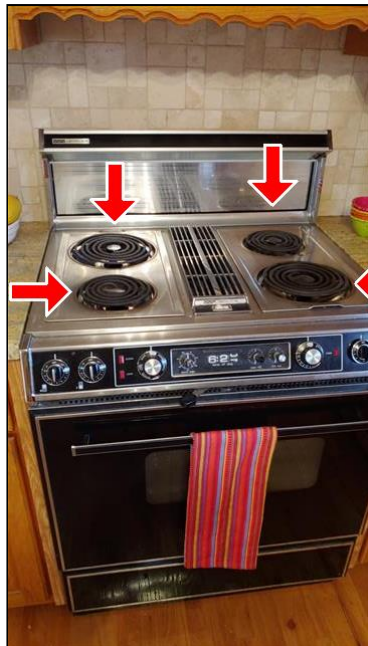
5.10 Item 2(Picture)

(2) Stove top/Oven functioned as designed.

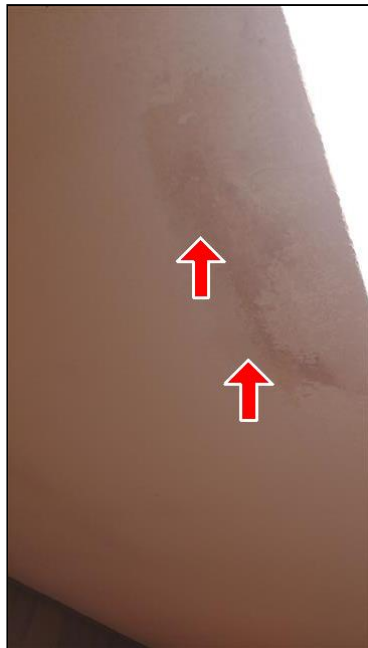
6.0 Item 1(Picture)

There is an area of ceiling in the family room (fire place room) near the skylight that shows signs of past water damage. At the time of the inspection, the area was dry (it had rained the night before).

The damage is likely old and came from the roofing mastic cracks along the skylight (see section 2.2) .

If concerned, suggest consultation with a qualified roofing company or general contractor as to repairs.

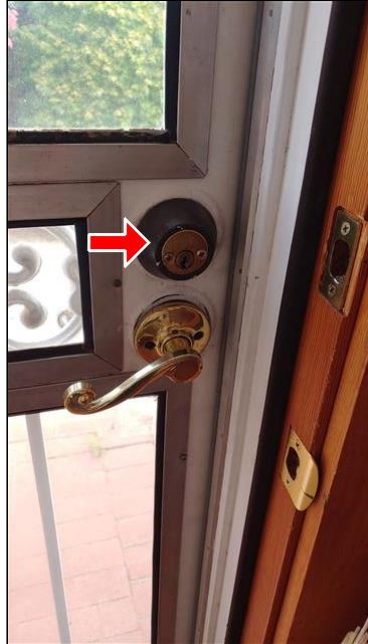
6.3 Item 1(Picture)

This is a safety hazard, as it may be difficult to locate the key in an emergency.

Suggest replacing the dead bolt with one that can be opened from the inside without a key.

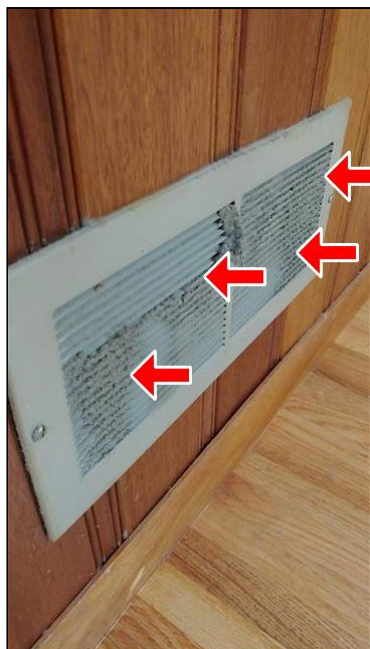
6.7 Item 1(Picture)

The family room's (fire place room) South wall HVAC duct has substantial lint build-up.

Suggest having the ducts cleaned prior to moving in.

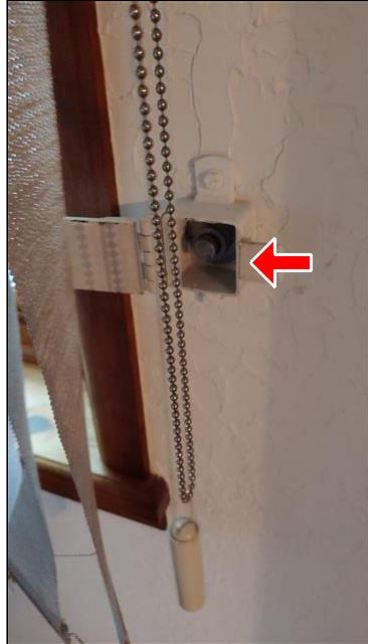
8.6 Item 1(Picture)

The security window door (off the master bedroom's office) does not function as designed. It will not open and the release button has been compressed.

This is a safety hazard. Strongly suggests consultation with a security window company as to repairs.

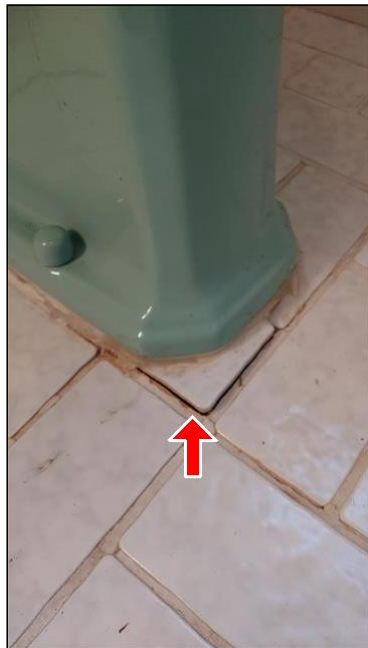
9.3 Item 1(Picture)

The toilet in the hall bathroom is loose and beginning to peel the tiles off the floor.

Suggest consultation with a licensed Plumber as to corrections.

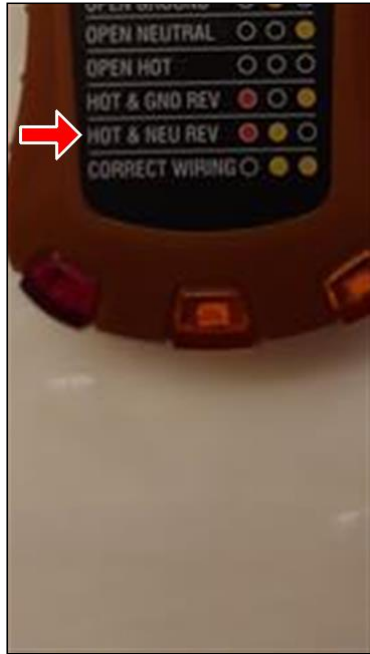
9.5 Item 1(Picture)

The bathroom outlet has a hot neutral/reverse.

Suggest further evaluation by a certified Electrician for repair or replacement.

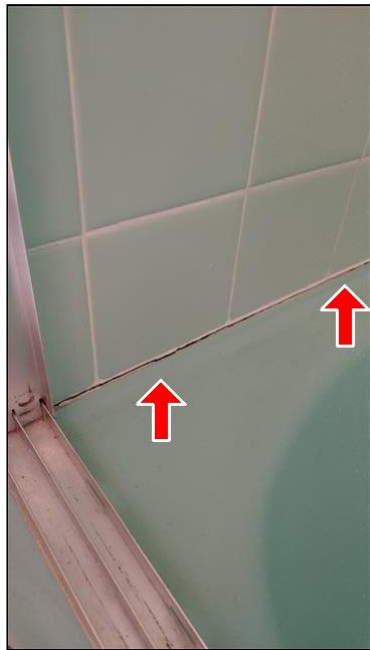
9.7 Item 1(Picture)

(1) The caulk on the back edge of the bathtub is beginning to fail/crack.

Suggest re-caulking the bath tub.

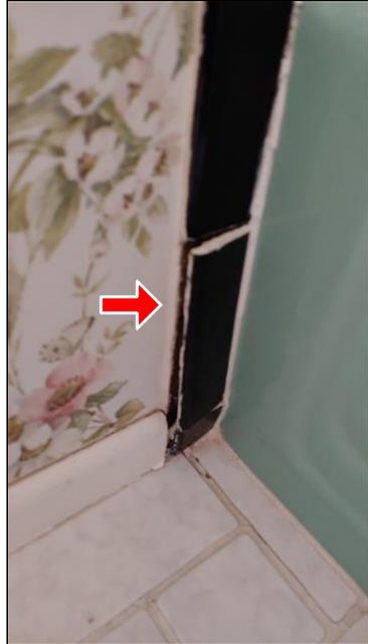
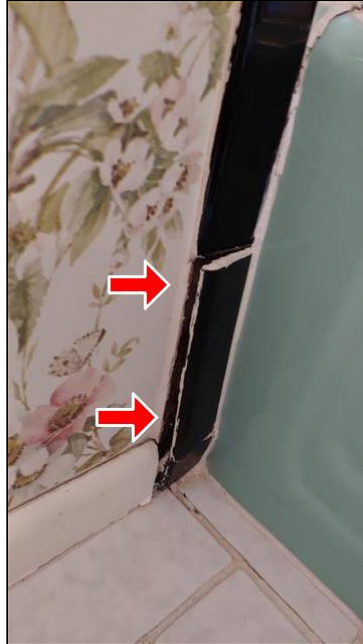
9.7 Item 3(Picture)

(2) The wall tile near the back of the tub is beginning to detach from the wall. This is likely due to water spilling out during showers when the door was not fully closed.

Suggest re-attaching the tiles and making sure the shower door is completely closed while showering.

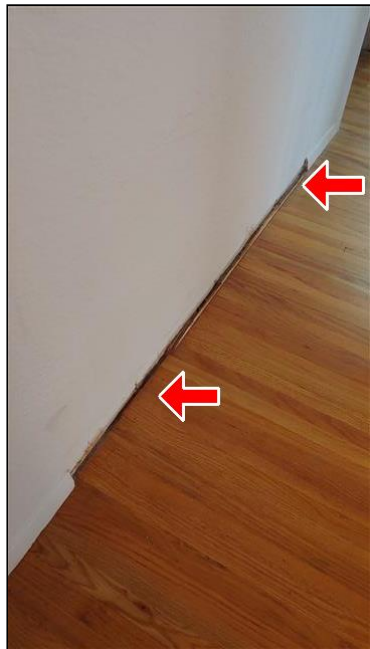
11.2 Item 1(Picture)

There is some trim missing on the south side of the hallway flooring.

Suggest replacing trim.

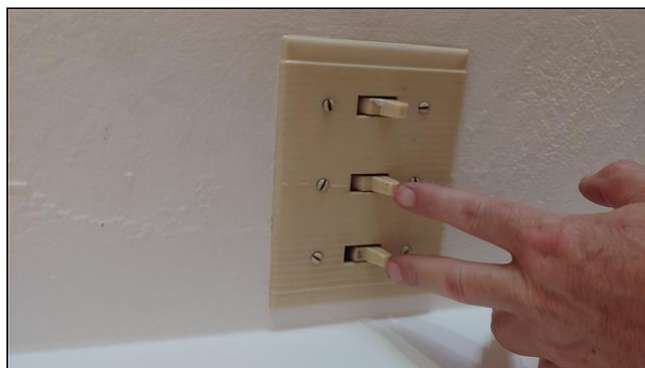
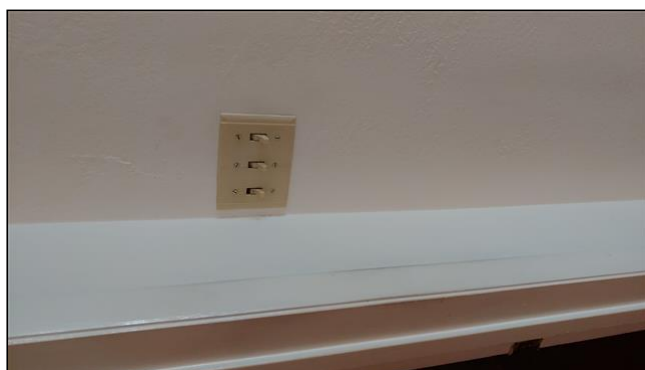
11.5 Item 4(Picture)

(2) The last two switches at the East end of the hallway near master bedroom did not seem to have a function. Suggest consultation with Sellers as to functionality of these switches.

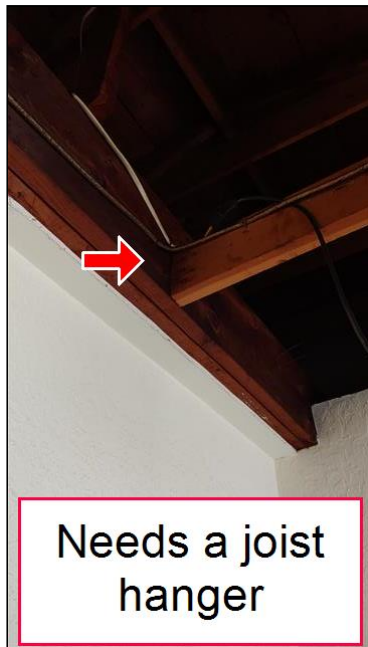
12.0 Item 1(Picture)

Due to the age of the home, many rafters in the overhead of the garage do not meet current safety standards.

Strongly suggest consultation with a certified contractor as to upgrades or corrections.

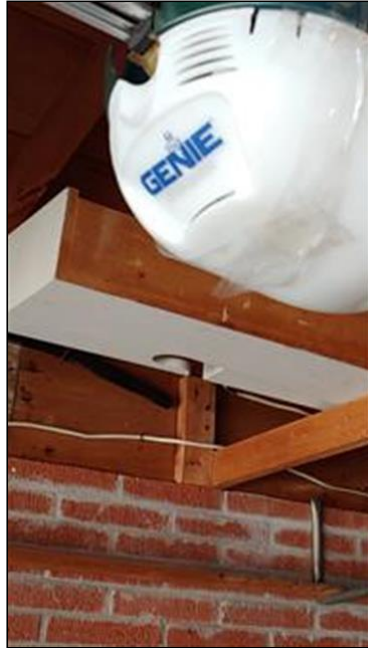
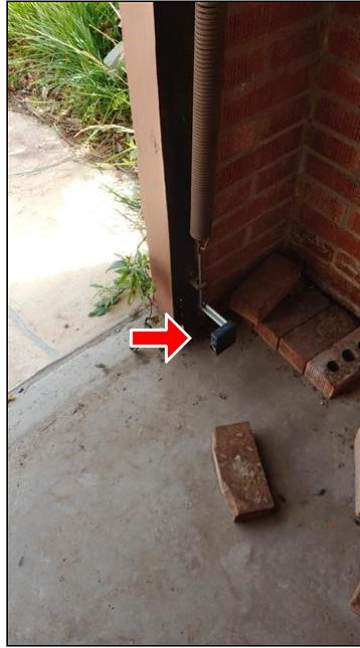
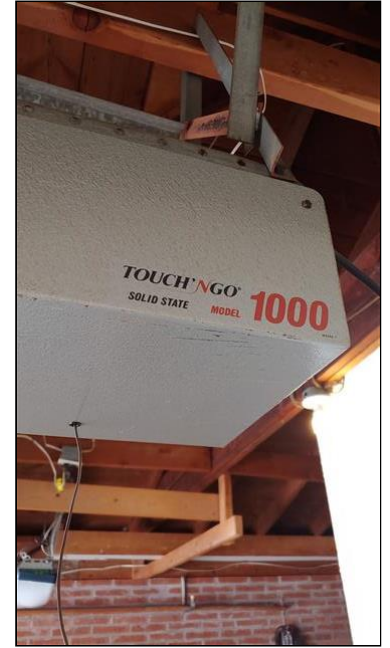
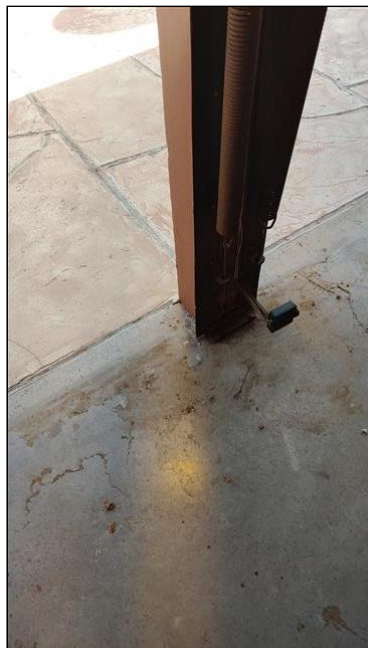
12.3 Item 1(Picture)

The garage door functions as designed from the wall switch. However, the East garage door has current safety features, while the West door does not have any safety features.

If concerned, suggest up-dating the west side garage door with current safety features.

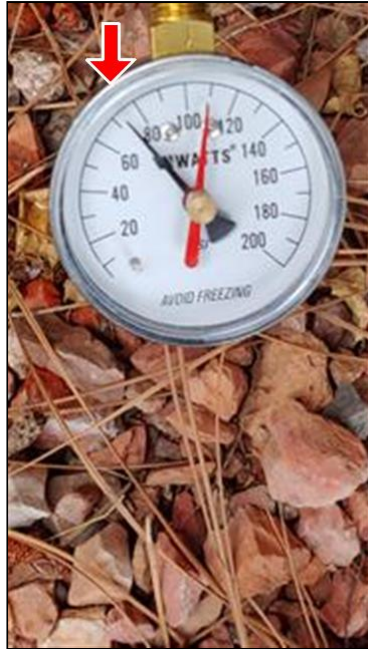
13.1 Item 1(Picture)

The water pressure should be between 40psi and 80psi. The home's water pressure is adequate.

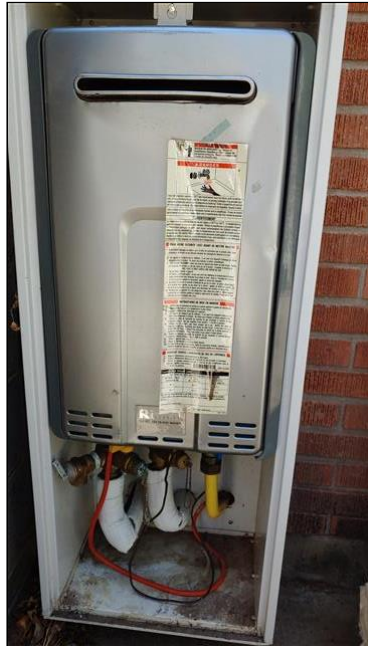
13.2 Item 1(Picture)

The hot water system is an on-demand water heater. Due to the numerous on-demand water heater systems and their widely varying installation requirements, I suggest further evaluation by a qualified HVAC company that is familiar with Rinnai on-demand water heater systems.

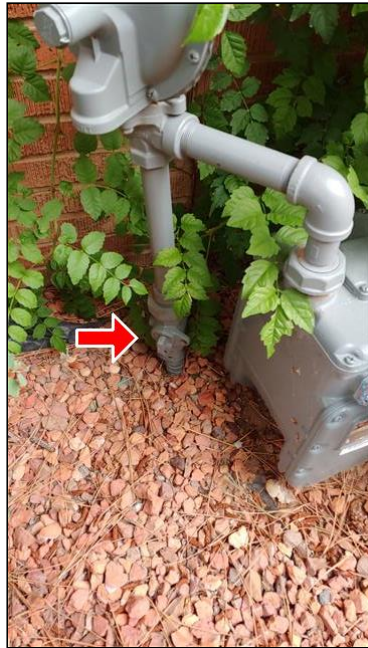
13.5 Item 1(Picture)

The main gas shut-off for the house is at the gas meter outside.

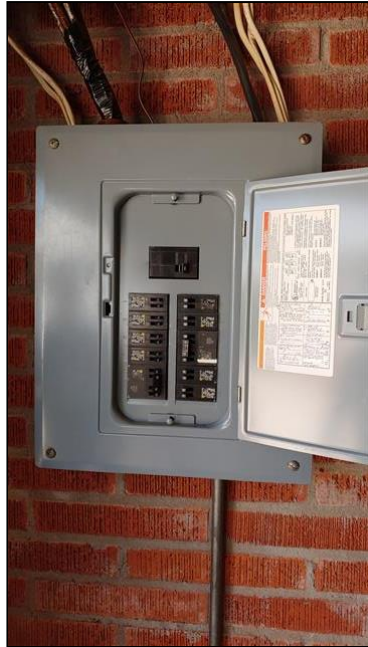
14.1 Item 1(Picture)

The main panel box is located in the garage.

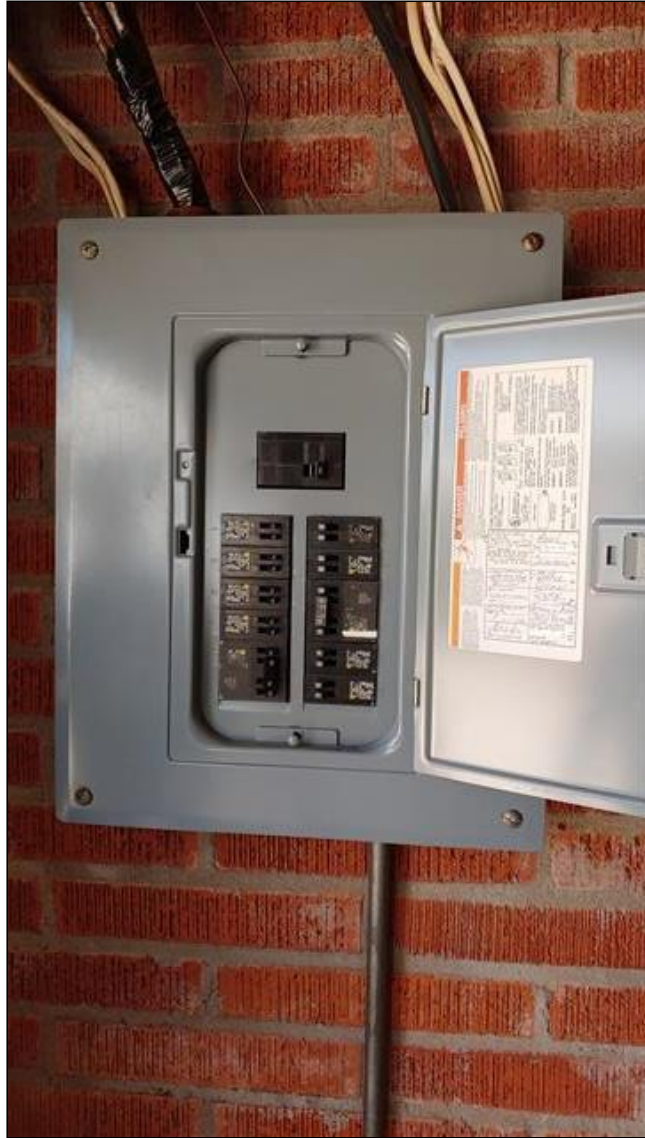
14.2 Item 1(Picture)

The distribution panel functioned as designed at the time of the inspection.

There should be a clear space in front of the main electrical panel at least 30 inches wide x 3 feet deep x 6 foot 6 inches tall.

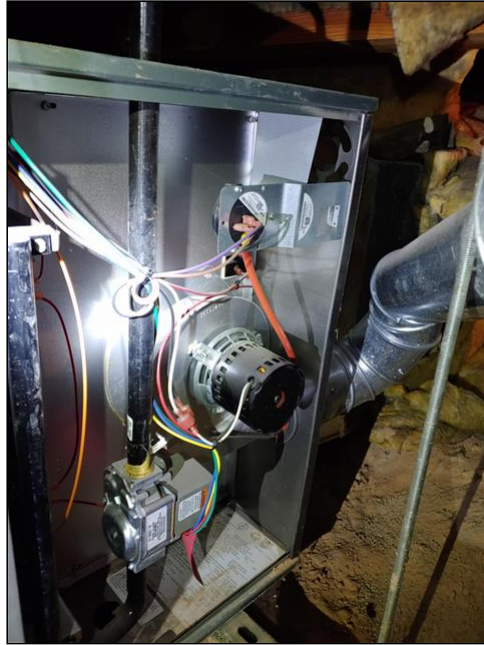
15.0 Item 1(Picture)

The serial number of this furnace indicates that it was manufactured in January of 2009, making the furnace 13 years old.

While most manufacturers' designed service life is 12-15 years, many furnaces do function well past the manufacturers' service life. However, there is no guarantee of life expectancy after the service life has been reached.

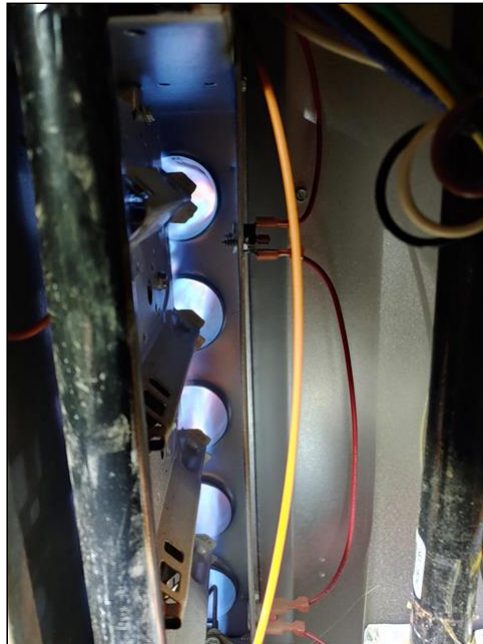
15.1 Item 1(Picture)

However, the door of the furnace is sprung and no longer closes properly. This causes the door safety shut-off switch to stay open, causing the furnace to remain off (red arrow). Eye Spy Home Inspections, LLC was able to test the unit by holding the door safety switch closed (by hand).

Suggest consultation by a qualified Rheem HVAC company representative for corrections.

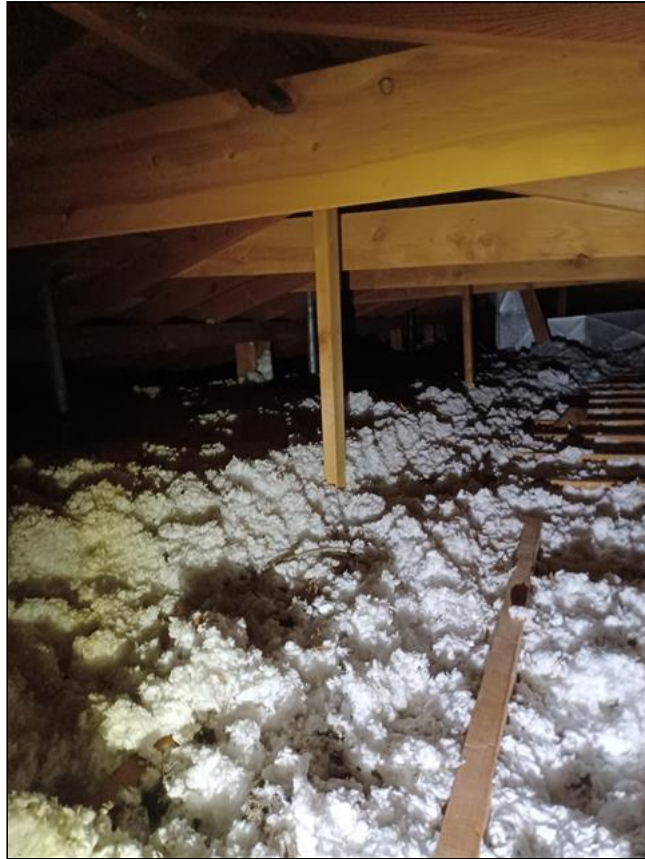
16.1 Item 1(Picture)

Attic has adequate insulation.

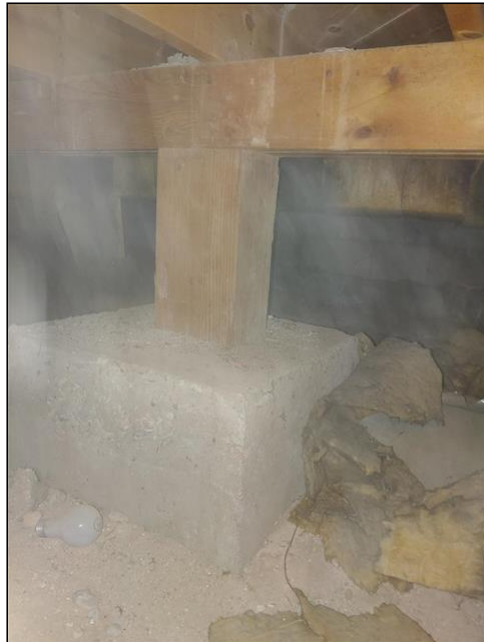
17.2 Item 1(Picture)

Columns and piers functioned as designed.

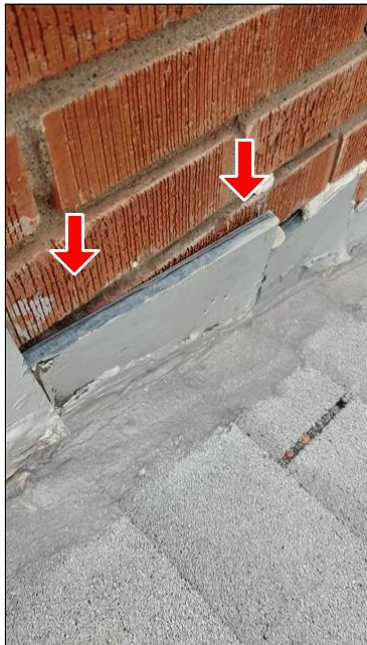
2.1 Item 1(Picture)

The step flashing on the chimney is improperly installed and the flashing sealant is beginning to deteriorate. Suggest consultation with a certified roofing company as to corrections.

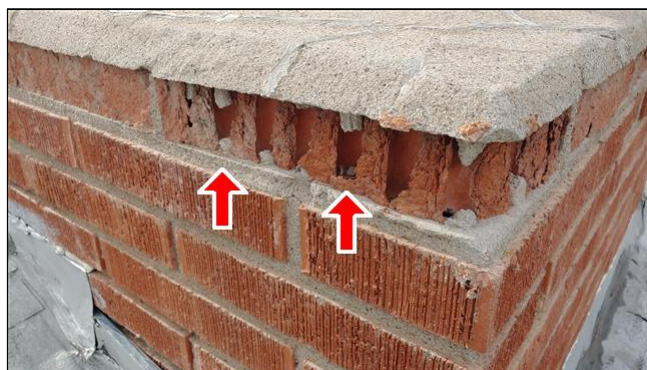
2.2 Item 1(Picture)

(1) The top row of brick around the chimney is beginning to spall and crack. Over time, this could lead to water damage to the chimney.

Suggest sealing the bricks or having the a new top layer of brick installed.

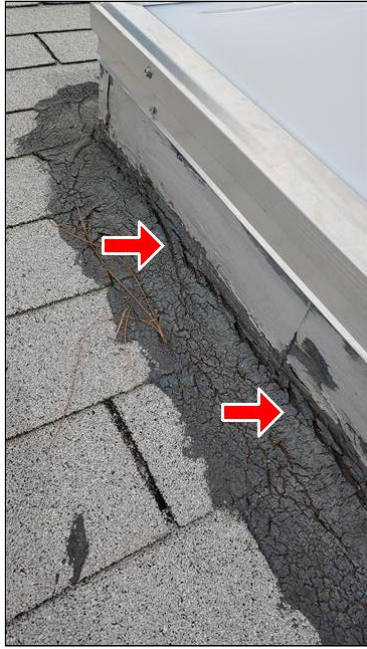
2.2 Item 4(Picture)

(2) The roofing mastic around the skylight is beginning to deteriorate and crack. This could lead to leaking into the home. Suggest re-sealing the roofing mastic around the skylight.

This skylight could be the source of the water damage in the family room (skylight near the fire place).

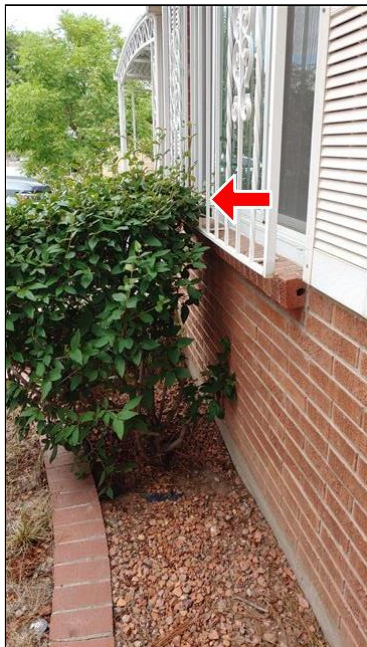
4.4 Item 1(Picture)

(1) Vegetation should be trimmed back and kept from touching the siding or the house. Vegetation can hold moisture and increase the possibility of moisture damage to walls, siding and foundations.

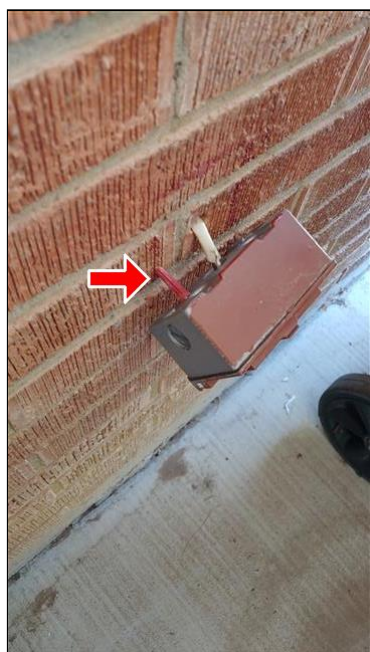
4.7 Item 2(Picture)

(2) The wall outlet on the North side of the garage is loose.

Suggest re-installing the outlet.

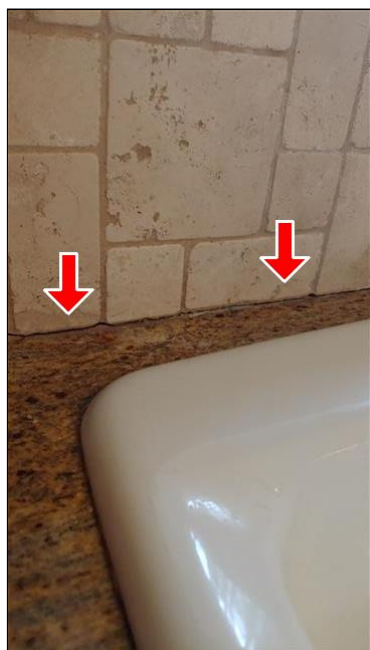
5.5 Item 1(Picture)

The kitchen counter grout at the back-splash is beginning to fail and crack.

Suggest re-grouting or caulking the back-splash.

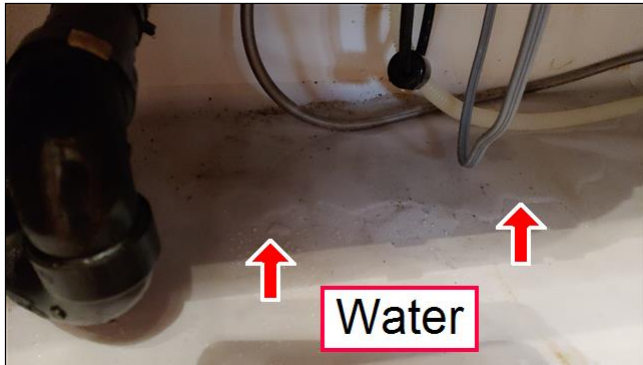
5.7 Item 1(Picture)

The kitchen faucet leaks.

Suggest replacing faucet.

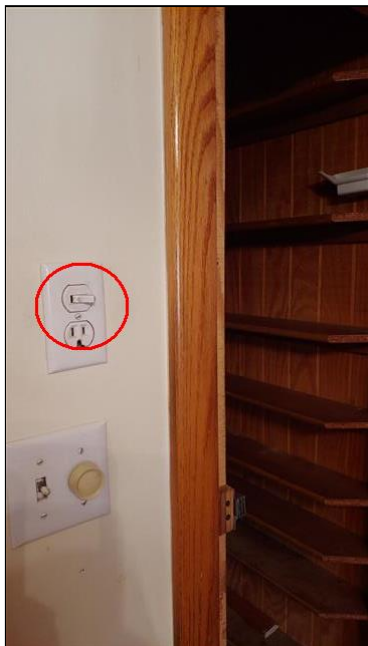
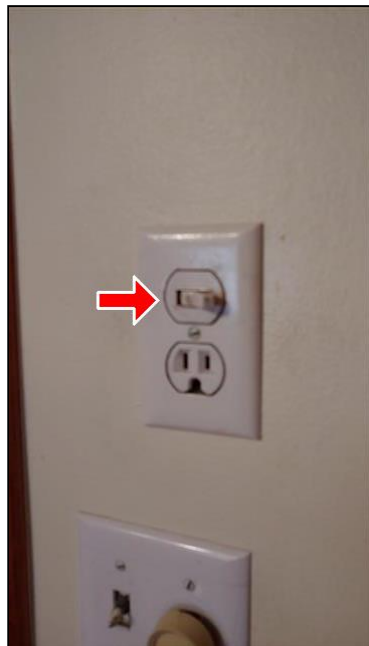
5.8 Item 1(Picture)

The overhead light switch for the pantry light does not function as designed.

Strongly suggest replacing switch.

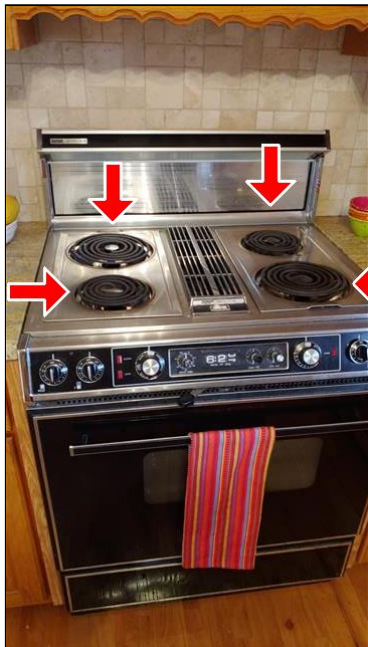
5.10 Item 2(Picture)

(2) Stove top/Oven functioned as designed.

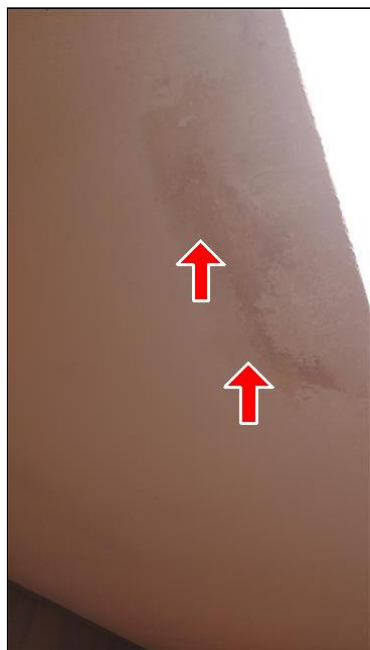
6.0 Item 1(Picture)

The damage is likely old and came from the roofing mastic cracks along the skylight (see section 2.2) .

If concerned, suggest consultation with a qualified roofing company or general contractor as to repairs.

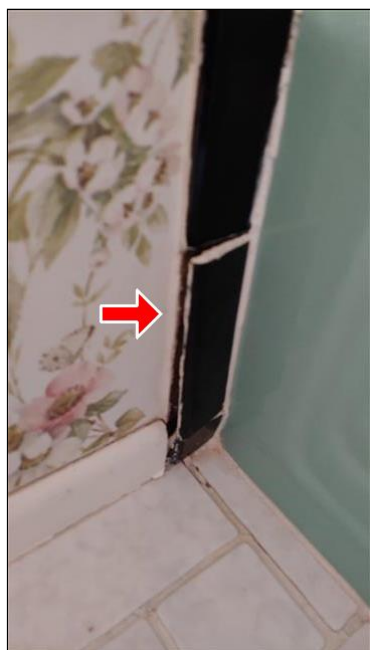
9.7 Item 3(Picture)

(2) The wall tile near the back of the tub is beginning to detach from the wall. This is likely due to water spilling out during showers when the door was not fully closed.

Suggest re-attaching the tiles and making sure the shower door is completely closed while showering.

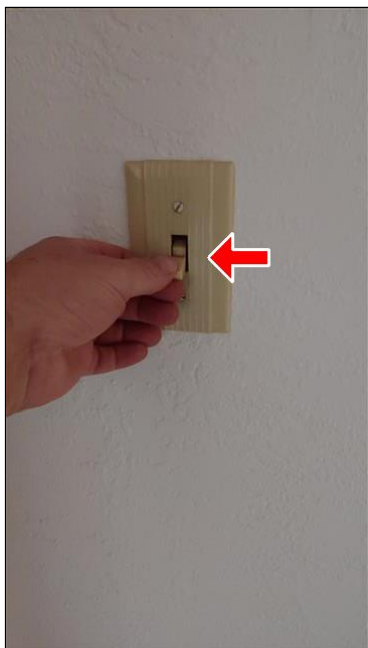
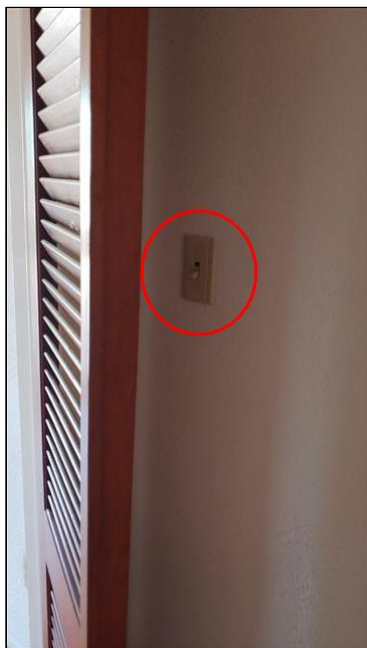
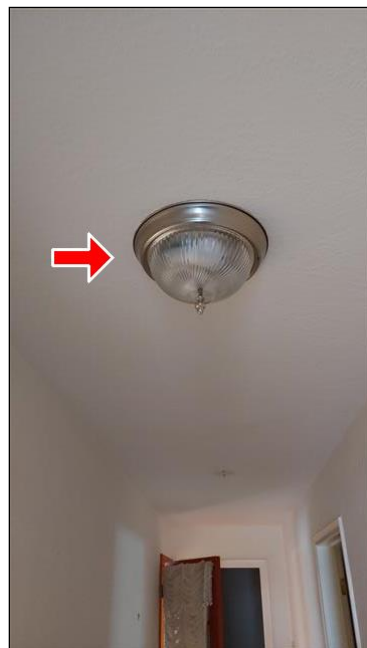
11.5 Item 1(Picture)

(1) The overhead light switch in the hall (near the hall closet) has a short.

Strongly suggest consultation with a certified Electrician as to corrections.

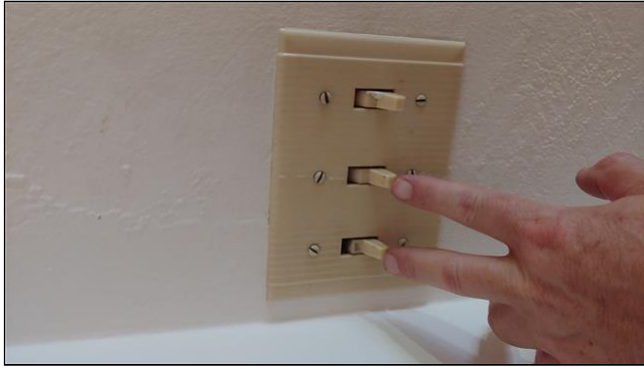
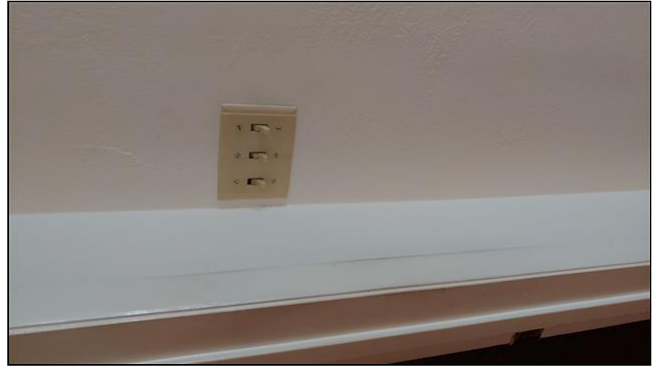
11.5 Item 4(Picture)

(2) The last two switches at the East end of the hallway near master bedroom did not seem to have a function. Suggest consultation with Sellers as to functionality of these switches.

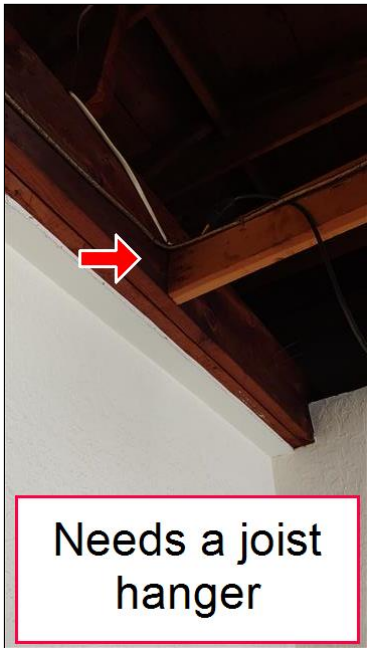
12.0 Item 1(Picture)

Due to the age of the home, many rafters in the overhead of the garage do not meet current safety standards.

Strongly suggest consultation with a certified contractor as to upgrades or corrections.

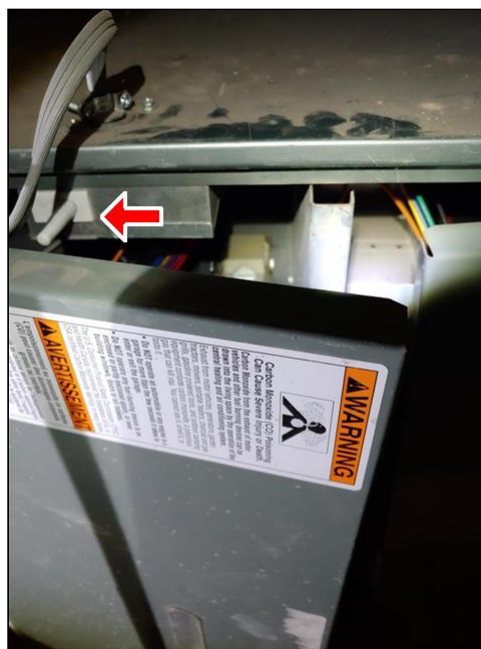
15.1 Item 2(Picture)

However, the door of the furnace is sprung and no longer closes properly. This causes the door safety shut-off switch to stay open, causing the furnace to remain off (red arrow). Eye Spy Home Inspections, LLC was able to test the unit by holding the door safety switch closed (by hand).
